Journal of Rock Art (JRA)

ASSESSING WEATHERING DAMAGE TO HELANKOU ROCK ART BY INTEGRATING MORPHOLOGICAL AND IN-SITU PERFORMANCE DATA

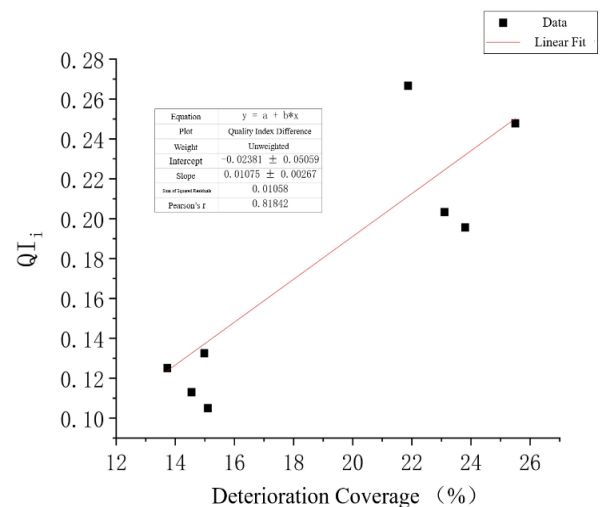
To quantitatively assess the relationship between structural deterioration and internal rock quality, a linear regression model was used to describe the relationship between deterioration coverage and QI_i (Figure 6). The analysis yielded a Pearson correlation coefficient of $r = 0.82$ ($p = 0.004$), indicating a statistically significant and strong positive linear relationship. This suggested that areas with higher QI_i values corresponded to greater deterioration coverage, providing a quantitative basis for predicting susceptibility to active damage.

Figure 6 Linear Regression Between Deterioration Coverage and QI_i

Moreover, the strong positive correlation between QI_i values and deterioration coverage suggests that QI_i is a robust quantitative proxy for internal void content and structural damage.

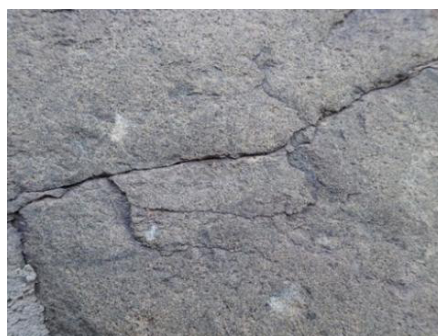
Figure 8 Schematic Diagram Showing Features of Blistering and Splitting

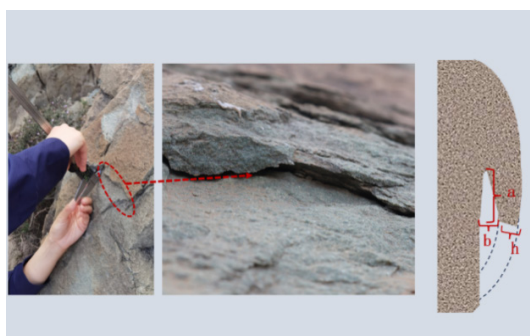
Figure 9 Schematic Diagram of Geometric Parameter Measurements of Splitting

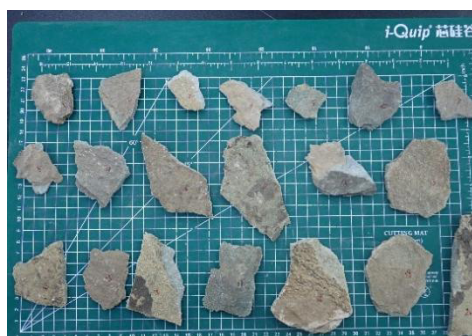
Figure 10 Schematic Diagram of Sheet-Like Detachment Morphology
