Journal of Rock Art (JRA)

Research on the Weathering Resistance of Phosphate-based Restoration Materials for Helankou Rock Art in Ningxia, China

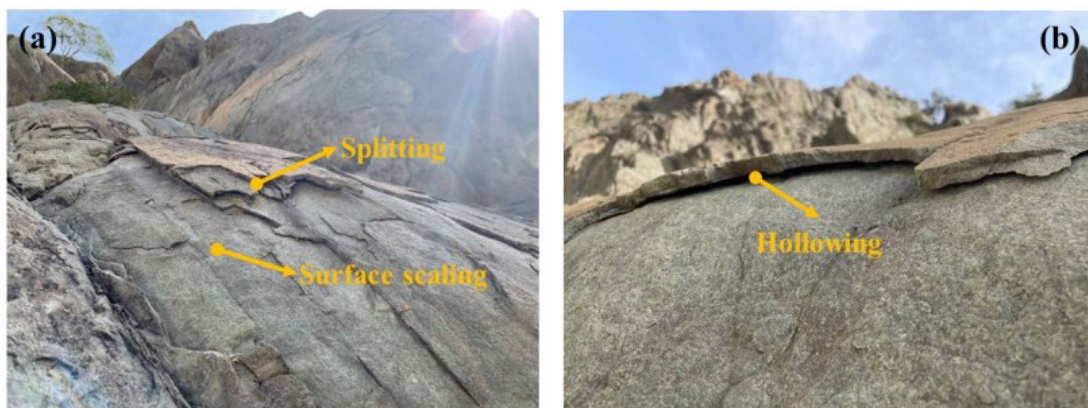
Figure 2 Typical Diseases in Helankou Rock Art: (a) Splitting with Parts of the Surface already Detached; (b) Hollowing with the Surface Separating from the Rock Body.

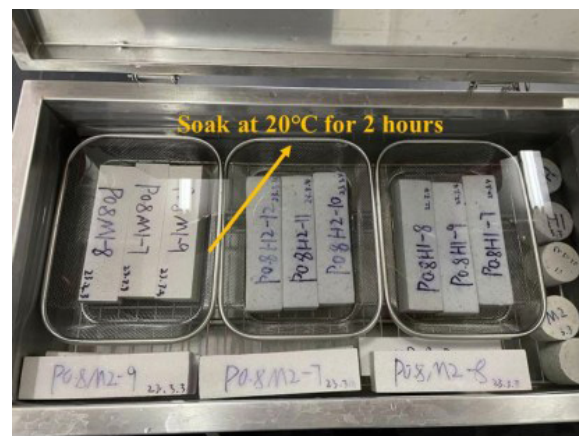
Figure 4 Wet-dry Cycling Test Using a Constant-Temperature Water Bath for Immersion

The specimens, cured for 28 days, were subjected to a wet-dry cycle. The samples were immersed in a constant-temperature water bath at 20°C for 2 hours (Figure 4), then dried in an oven at 70°C for 4 hours for one

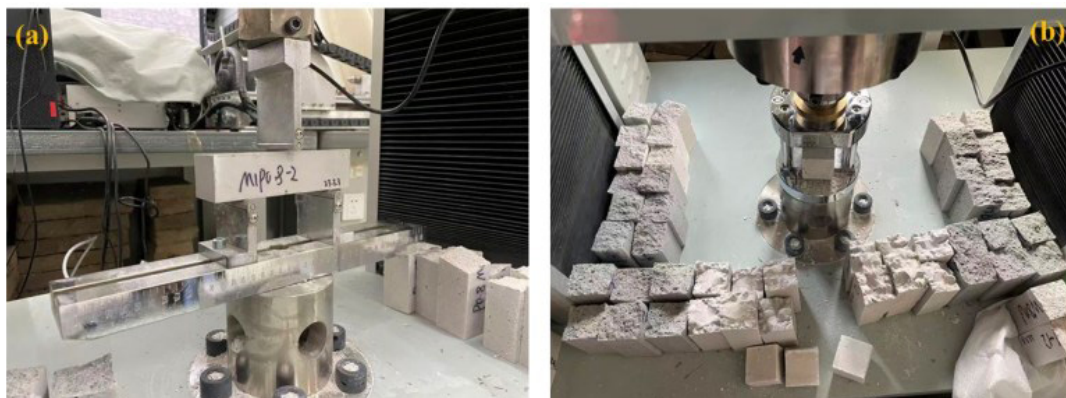
Figure 6 Flexural and Compressive Strength Measurements Conducted with a WDW-300 Electronic Universal Testing Machine: (a) Flexural Strength Test; (b) Compressive Strength Test.

Compressive and flexural strengths were tested using a WDW-300 electronic universal testing machine according to GB/T 17671-2020 Testing Methods for Cement Mortar Strength (ISO method). After flexural testing, six specimens were used for subsequent compressive strength testing. The flexural strength testing rate was 50 N/s \pm 10 N/s, and the compressive strength testing rate was 2.4 kN/s \pm 0.2 kN/s (Figure 6).

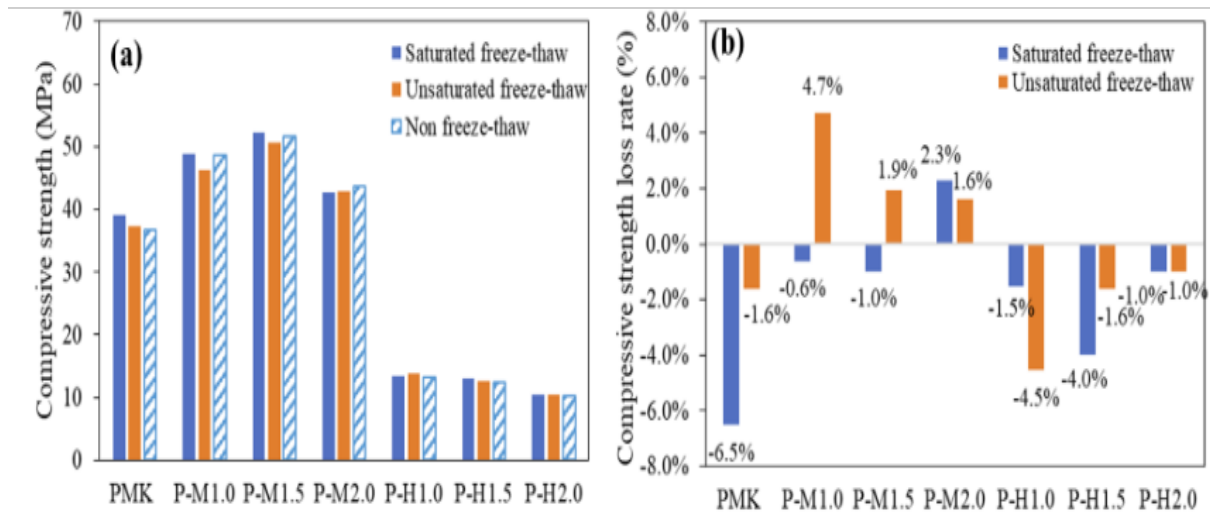
Figure 7 Comparison of Compressive Strength under Two Freeze-thaw Conditions after 28 Days: (a) Compressive Strength; (b) Compressive Strength Loss Rate.

For the mortars with added aggregates, the strength and loss rate responses varied significantly. The P-M (mullite) mortar had a compressive strength range of 43.6–51.7 MPa before freeze-thaw cycling. After 20 cycles, the compressive strength ranged from 42.6–52.2 MPa under saturated conditions and 42.9–50.7 MPa under non-saturated conditions. The compressive loss rates ranged from -1.0% to +2.3% in saturated conditions and from +1.6% to +4.7% in non-saturated conditions. The flexural strength of P-M ranged from 5.3–6.0 MPa, increasing to 5.8–6.6 MPa under saturated conditions (-3.6% to -13.2% loss) and 5.2–5.8 MPa under non-saturated conditions (0-+7.1% loss). This indicates that in the absence of sufficient water, slight reductions in tensile properties may occur.

In comparison, the P-H (Helankou sandstone) mortar exhibited lower strength levels, with compressive strength ranging from 10.3–13.2 MPa before freeze-thaw cycling and flexural strength from 2.1–2.8 MPa. After the freeze-thaw cycles, the compressive strength showed negative losses in both saturated and non-saturated conditions (around -1.0% to -4.5%), while flexural strength mostly exhibited positive losses (saturated conditions: +3.8% to +7.1%; non-saturated conditions: 0-+10.7%). This suggests that the freeze-thaw response

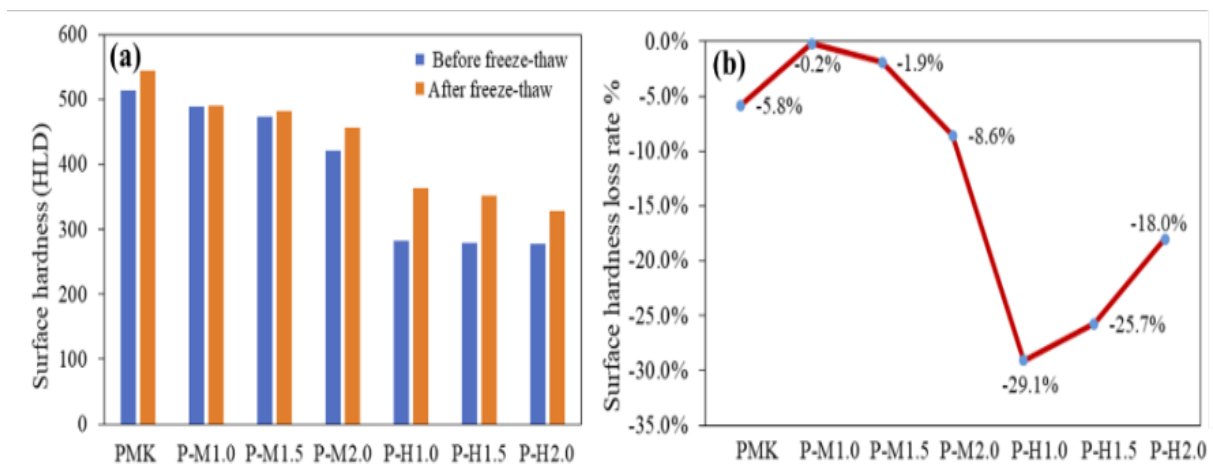
Figure 9 (a) Surface Hardness before and after Freeze-thaw Cycling; (b) Surface Hardness Loss Rate.

Under saturated conditions, after 20 freeze-thaw cycles, the surface hardness of all specimens did not decrease; in fact, it generally increased (Figure 9), indicating that the system demonstrated good surface stability under freeze-thaw and wet conditions. The surface hardness of the neat paste (PMK) increased from 515 HLD to 545 HLD, with a change rate of -5.8% . The P-M system (mullite aggregates) showed a relatively high surface hardness before freeze-thaw cycling (421–489 HLD). After cycling, the surface hardness ranged from 457 to 490 HLD, with changes between -0.2% and -8.6% . The P-H system (Helankou sandstone aggregate) had a lower initial hardness (278–282 HLD), which increased to 328–364 HLD after cycling, with a change rate of -18.0% to -29.1% . Therefore, in terms of absolute values, the surface hardness ranking was $PMK \approx P-M > P-H$. In terms of relative changes, the order was $P-H > PMK > P-M$, with P-H showing the largest improvement, though its surface hardness remained lower than that of P-M.

The observed increase in surface hardness and the negative loss rate suggest that the freeze-thaw phase was not dominated by surface erosion or softening, but rather by surface densification caused by ongoing reactions and pore refinement. Comparing the materials, P-M exhibited higher surface hardness before freeze-thaw cycling, with smaller variations, indicating a more stable surface and interface structure. In contrast, P-H had lower initial hardness but showed a larger increase, suggesting that the near-surface layer had more pores and defects that could be “repaired or filled” through hydration or deposition. However, due to limitations imposed by the aggregate and ITZ quality, its final surface hardness remained lower than P-M.

Further analysis of the gradation effect revealed that for P-M, gradations of 1.0/1.5 resulted in mild increases in hardness (-0.2% and -1.9%), while the 2.0 gradation showed a more noticeable increase (-8.6%). For P-H, the largest improvement occurred in the 1.0 gradation (-29.1%), indicating a strong surface densification effect. However, this advantage did not translate into higher absolute hardness, further reinforcing that the controlling factors for P-H were more related to the interface and aggregate properties.

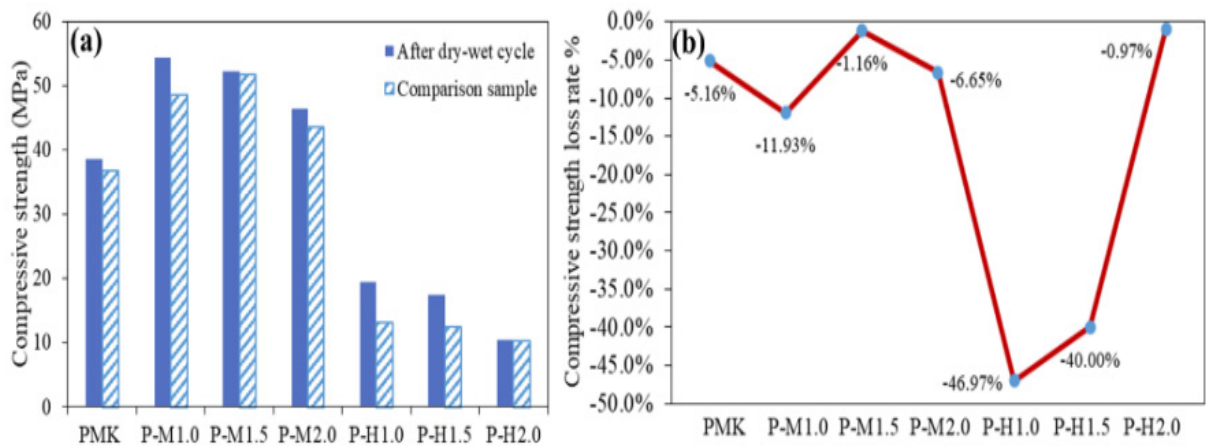
Figure 11 (a) Comparison of Compressive Strength between Specimens after Wet-dry Cycling and Control Specimens; (b) Compressive Strength Loss Rates.

After wet-dry cycling, all systems showed varying degrees of improvement in compressive strength (Figure 11), indicating that the wetting phase of the cycle promoted continued reactions and pore filling, positively contributing to the compressive load capacity. The compressive strength of PMK increased from 36.8 MPa to 38.7 MPa, with a loss rate of -5.16%. The P-M mortar with mullite aggregates showed an increase in compressive strength from 43.6–51.7 MPa to 46.5–54.4 MPa, with a loss rate ranging from -1.16% to -11.93%, with P-M1.0 showing the largest improvement. The P-H mortar with Helankou sandstone aggregate showed an increase from 10.3–13.2 MPa to 10.4–19.4 MPa, with a loss rate ranging from -0.97% to -46.97%, with the most significant improvements in the P-H1.0 and P-H1.5 gradations. Overall, the inclusion of aggregates significantly raised the baseline compressive strength (P-M >> PMK > P-H), and the materials retained or further improved their strength after the wet-dry cycling, reflecting the excellent volume stability and structural recoverability of the systems.

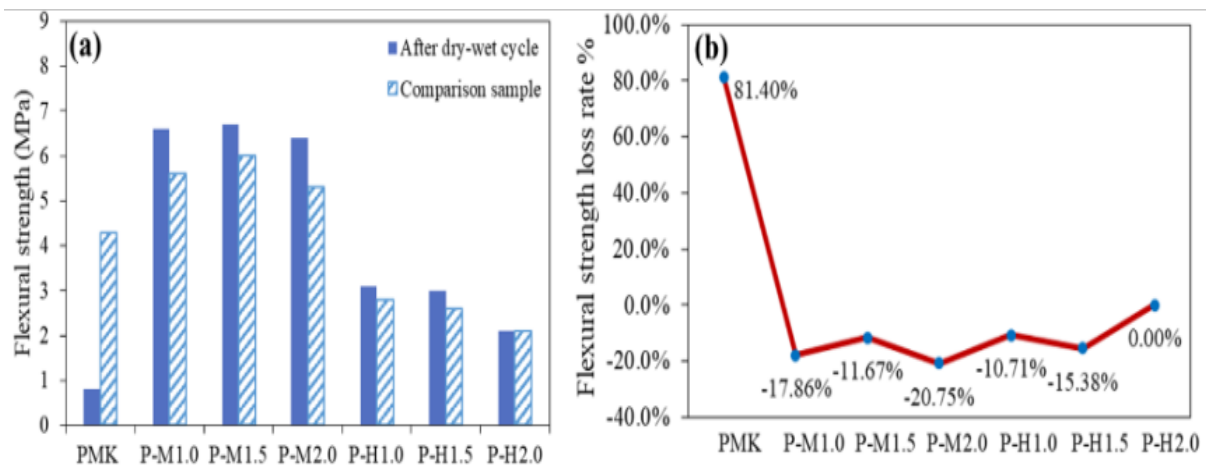
Figure 12 (a) Comparison of Flexural Strength between Specimens after Wet-dry Cycling and Control Specimens; (b) Flexural Strength Loss Rates.

In contrast to compressive strength, flexural strength was more sensitive to wet-dry cycling, showing a clear contrast between the neat paste and the mortars (Figure 12). The flexural strength of PMK dropped sharply from 4.3 MPa to 0.8 MPa (a loss of +81.40%), showing that dehydration shrinkage during the drying phase more easily induced microcracks in the paste, weakening its tensile load capacity. In contrast, the mortars with aggregates did not experience such a significant decline in flexural strength. The flexural strength of P-M increased from 5.3–6.0 MPa to 6.4–6.7 MPa (a loss rate of -11.67% to -20.75%), while P-H flexural

strength increased from 2.1–2.8 MPa to 2.1–3.1 MPa (a loss rate of 0% to -15.38%). These results indicate that the aggregate framework effectively restrained the drying shrinkage and microcrack propagation, maintaining the tensile strength of the mortar during the wet-dry cycles. This also highlights that for this type of phosphate-based restoration material, the major durability limitation under wet-dry cycling lies in the tensile properties of the neat paste, while the introduction of aggregates improves its overall durability.

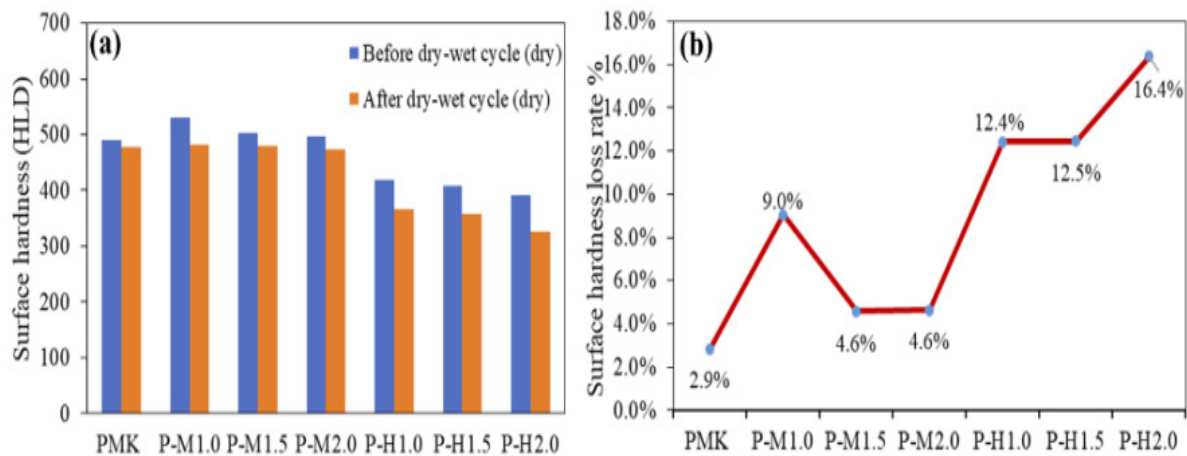
Figure 13 (a) Surface Hardness of Dry Specimens before and after Wet-dry Cycling; (b) Surface Hardness Loss Rate.

in Figure 13. After completing the wet-dry cycling, the surface hardness of the neat paste (PMK) decreased from 491 HLD to 477 HLD, with a loss rate of 2.85%, indicating that the drying phase of the cycle induced shrinkage and microcrack accumulation on the surface, which reduced the rebound response.

For the mortars with aggregates, the changes in surface hardness were also observed, with the degree of loss closely linked to the type of aggregate and its gradation. The mullite mortar (P-M) showed a decrease in hardness from 496–531 HLD to 473–483 HLD, with a loss rate ranging from 4.6% to 9.0%. The greatest reduction was observed in P-M1.0 (531 → 483 HLD, 9.0%), while P-M1.5 and P-M2.0 exhibited more stable hardness values. The P-H mortar (Helankou sandstone aggregate) showed a decrease in hardness from 391–418 HLD to 327–366 HLD, with a loss rate of 12.4%–16.4%, which was significantly higher than the P-M system, and the degradation became more pronounced with increasing gradation (P-H2.0 had the largest reduction, 391 → 327 HLD, 16.4%).

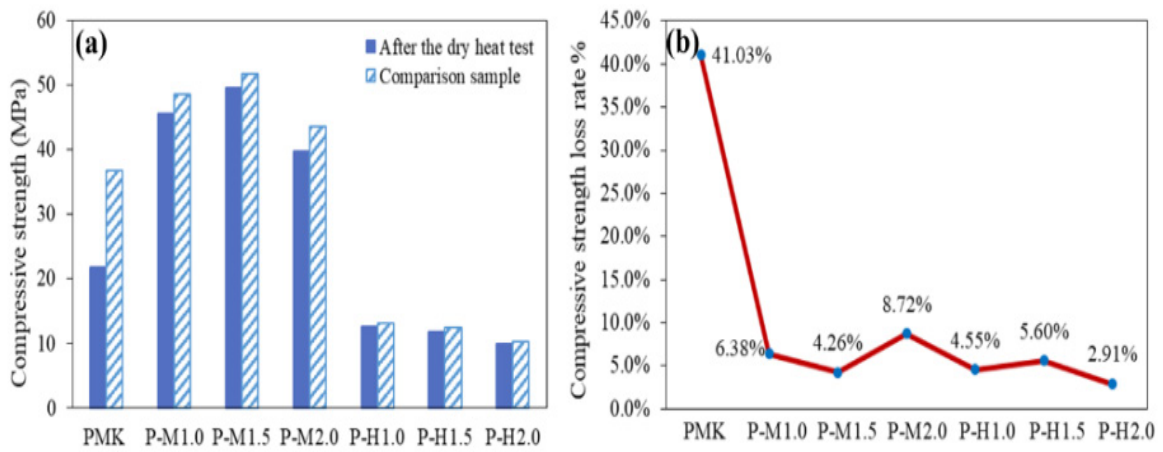
Figure 15 (a) Compressive Strength Comparison between Dry-heat Specimens and Control Specimens; (b) Compressive Strength Loss Rate.

The results from the dry-heat aging process are shown in Figures 15 and 16, demonstrating significant irreversible structural changes. The neat paste (PMK) showed a marked decrease in strength under dry-heat

aging. The compressive strength dropped from 36.8 MPa to 21.7 MPa (a loss rate of 41.03%), and the flexural strength decreased sharply from 4.3 MPa to 0.4 MPa (a loss rate of 90.70%), indicating that the neat paste was particularly susceptible to deterioration in tensile capacity under dry-heat conditions.

In contrast, the mortars with aggregates showed significantly improved strength retention. For the P-M mortar, the compressive strength loss was only between 4.26%–8.72%, and the flexural strength loss ranged from 3.77% to 5.36%, demonstrating the most stable dry-heat durability. The P-H mortar exhibited a compressive strength loss between 2.91%–5.60%, while the flexural strength loss ranged from 11.54% to 19.05%. The P-H2.0 gradation was the most sensitive, suggesting that the sandstone-based system was still more prone to interface defects and crack propagation, affecting its tensile properties.

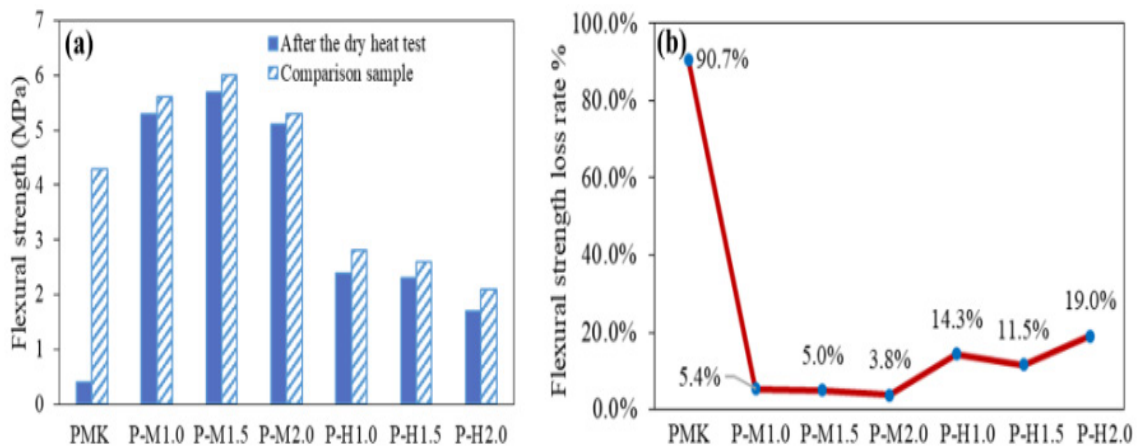
Figure 16 (a) Flexural Strength Comparison between Dry-heat Specimens and Control Specimens; (b) Flexural Strength Loss Rate.

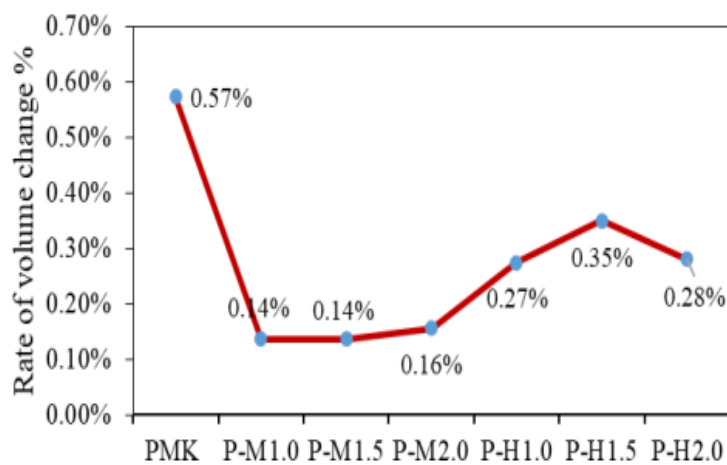
Figure 18 Volume Change Rate after 300 Hours of Dry-heat Aging

The volume change rate after 300 hours of dry-heat aging at 70°C is shown in Figure 18, demonstrating the material's dimensional stability under dry-heat conditions. All specimens exhibited low volume change rates, ranging from 0.14% to 0.57%, indicating overall good dimensional stability. The neat paste (PMK) had the largest volume change rate at 0.57%, while the addition of aggregates significantly reduced this rate. The P-M system showed a volume change rate between 0.14%–0.16%, with minimal variation across different gradations, indicating a stable constraint effect from the mullite aggregates on volume shrinkage induced by dry-heat aging. The P-H system had a volume change rate ranging from 0.27% to 0.35%, which was higher than that of the P-M system but still lower than that of the neat paste, showing that the sandstone aggregates also helped mitigate macroscopic volume changes but were more sensitive to gradation and interface conditions.

Overall, the volume change rate followed the trend: PMK > P-H > P-M, with the P-M system exhibiting the best stability. This suggests that the introduction of aggregates, particularly mullite, plays a crucial role in improving the material's resistance to volume shrinkage under dry-heat conditions, with the P-M system showing the most consistent and stable behavior.
