JOURNAL OF ROCK ART (JRA)

WEATHERING DISEASE CHARACTERISTICS AND IMPACT ASSESSMENT OF HELANKOU ROCK ART

This study investigated the distribution and types of surface weathering diseases on rock art in the Helankou area, using field surveys and statistical analyses. In addition, a damage index analysis method was proposed to quantify the effect of weathering diseases on the integrity and preservation status of the artefacts. The study findings revealed that the weathering diseases affecting the rock art in Helankou primarily encompass surface delamination, splitting, and blistering. Significant variations were observed in the extent of damage to the rock art depending on the rock surface type. Spheroidal surfaces and vertical planes typically exhibit more pronounced damage, whereas parallel planes experience a relatively lower impact. A comparative analysis of the damage indices revealed that the most significant disease affecting the integrity and preservation status of the rock art is delamination, which is predominantly observed on the surfaces of spheroidal weathering planes. This study will facilitate the development of protective measures for paintings. This will lead to imp

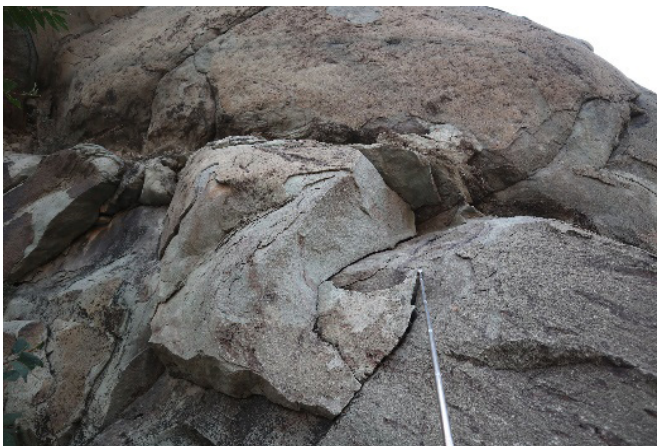
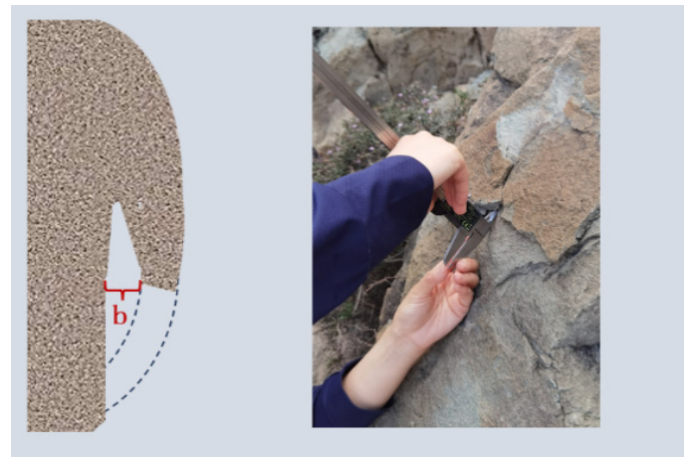
Figure 6: Splitting Image

Splitting refers to the phenomenon in which various fissures intersect within the rock art surface, causing the stone to fracture along planes of weakness, such as microcracks or clay, without completely peeling

off. Fissures and cracks at different developmental stages contribute to surface integrity damage. For statistical convenience, we merged and tallied the splitting but provided specific markings for different splittings. The geometric form of the splitting damage was measured (Fig. 6), where 'b' represents the width of the split, and the estimated split area was the product of the length and width. The resulting flaking caused by this disease poses a serious threat to the long-term

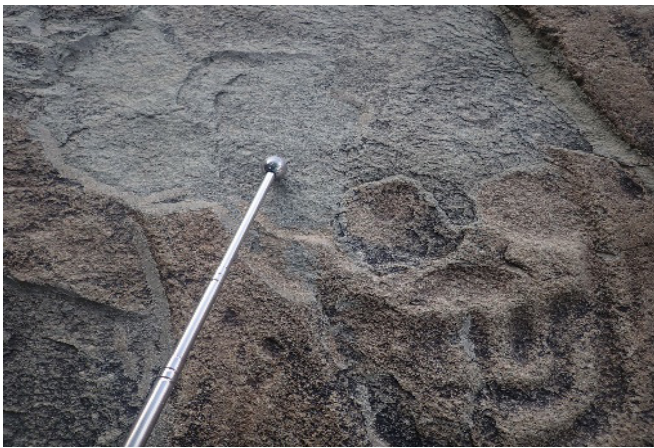
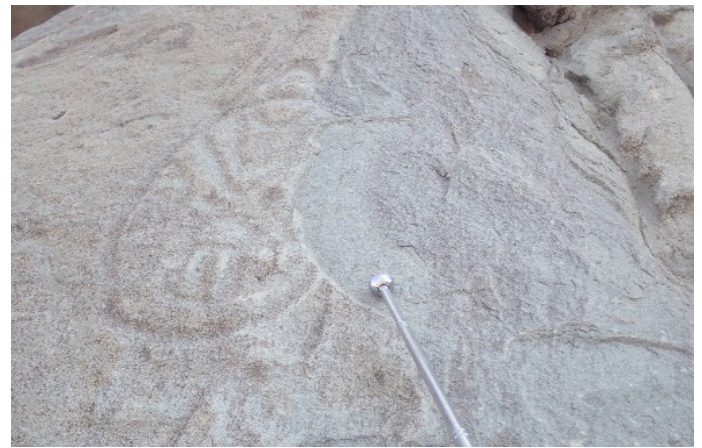
Figure 7: Delamination Image

Detachment refers to the gradual separation of the surface layer of the rock art from the rock mass. It involves physical separation into one or multiple layers of various thicknesses and diverse forms, including detachment and scaling. Helankou rock art mainly exhibits surface delamination (Fig. 7), which is a type of surface damage that significantly impacts the deterioration of cultural stone relics. Without a proper basis, it is usually impossible to repair the surface loss of stone cultural heritage artefacts.

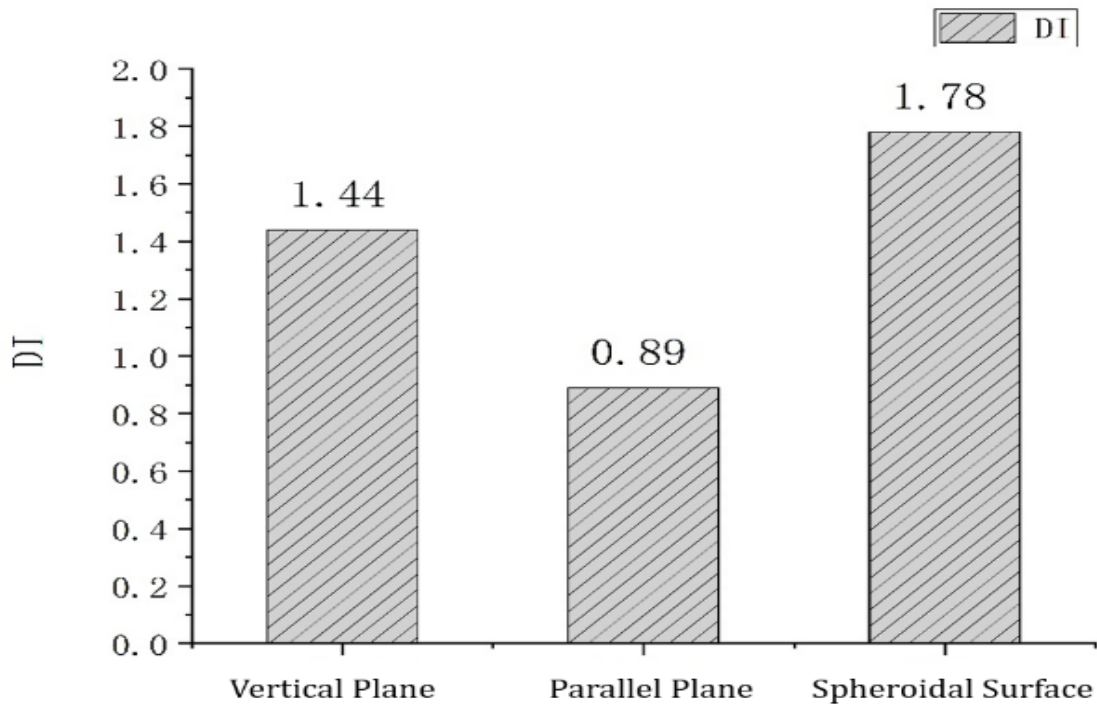
Figure 14: Blistering Disease Coverage Rate

Fig. 14 shows significant differences in the severity of damage that affected the rock art on different surfaces. Artwork on vertical and spherical weathered surfaces experienced higher levels of damage, whereas those on parallel planes were relatively less affected. This difference may be related to the geological weathering process in the area and the exposure conditions in the rock art locations.

Rock art on vertical planes is frequently found in rock substrates containing dense joint systems that render the rock more permeable. Thus, these areas are more susceptible to temperature and water influence, which accelerate the weathering process of the rock and make art more prone to damage. Contrarily, spherical weathered surfaces are formed when multiple sets of joints divide a rock into polyhedral blocks. The edges and corners of these smaller rocks are initially prone to damage, which results in significant erosion. Over time, the edges of the rock gradually erode, forming spherical or ellipsoidal weathered formations. Rock art carved on spherical surfaces is more susceptible to mechanical damage, leading to overall high levels of damage.
